Osteochondral Autologous Transfer Surgery (OATS)

using Hyalofast® One-Step Cartilage Repair

Professor Paul Y F Lee MSK Doctors, London Sports Injury Clinic, London Cartilage Clinic

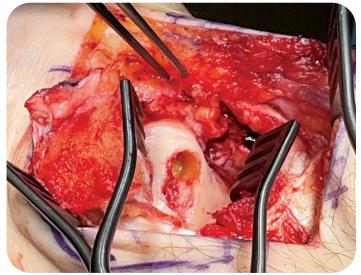
Figure 2

Two osteochondral plugs were removed from the osteochondral lesion on the talus with an OATS device to a depth of 14mm.
